Home Diagnostic Inspections, Inc.
Property Inspection Report

10 Anywhere Ave., Somewhere NJ, 00000
Inspection prepared for: John Doe & Jane Doe
Agent: Tom Moore - Remax, Montvale

Inspection Date: 2/2/2011 Time: 10:00am
Age: 1950s Size: 2200 sq. feet
Weather: Snow 32 degrees

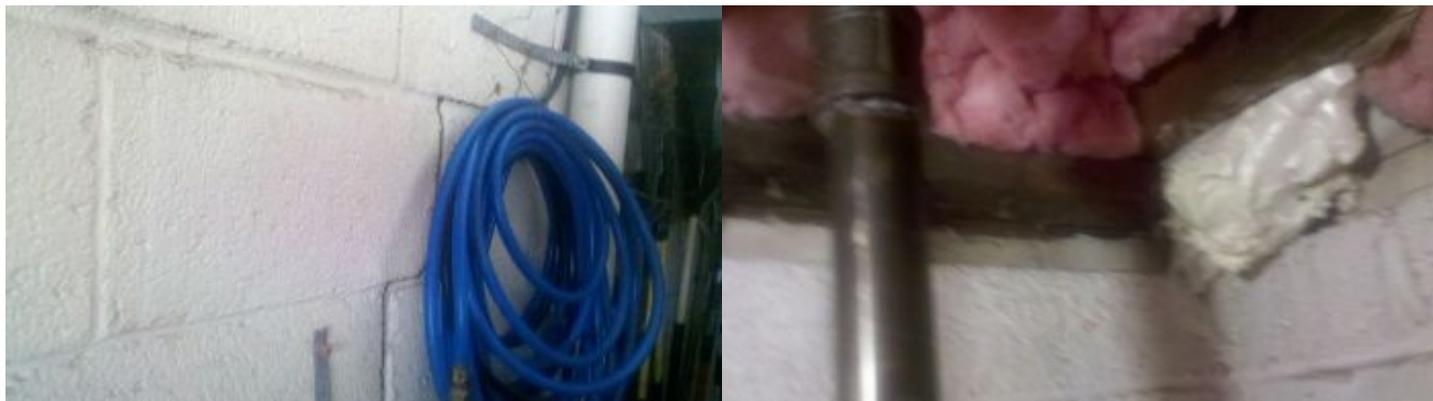
- A diagonal crack was noted in the foundation front wall. This crack appears to be stable at this time. It is not wider than 1/8 of an inch at any point, and there does not appear to be any sweep or buldge in the foundation. This crack should be monitored for future movement.
- Vertical cracks noted in foundation. Fiill and seal cracks. Monitor for future movement.
- Termite shelters tubes noted on: the front sill and rim joist. Treatment is required. The wood in the area is intact, and does not need repair at this time.

foundation crack

Termite tubes in sill plate and rim joist

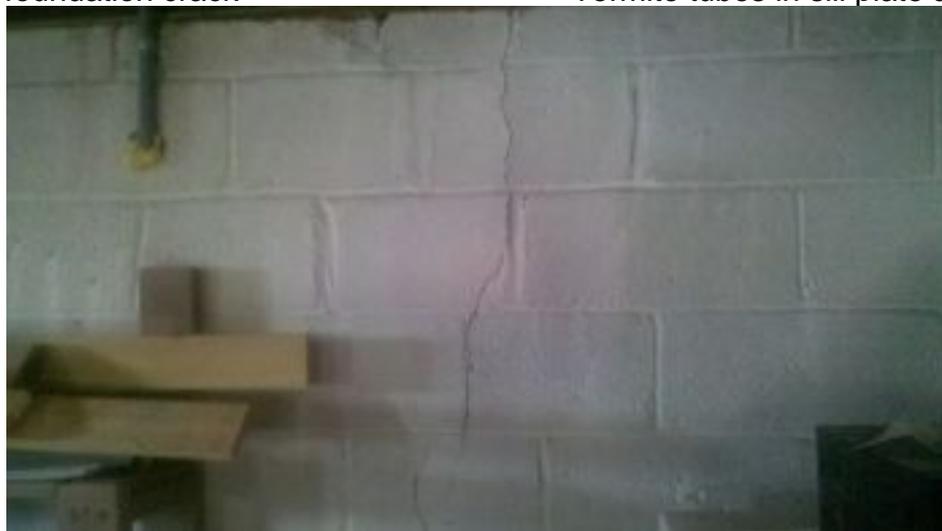
foundation crack

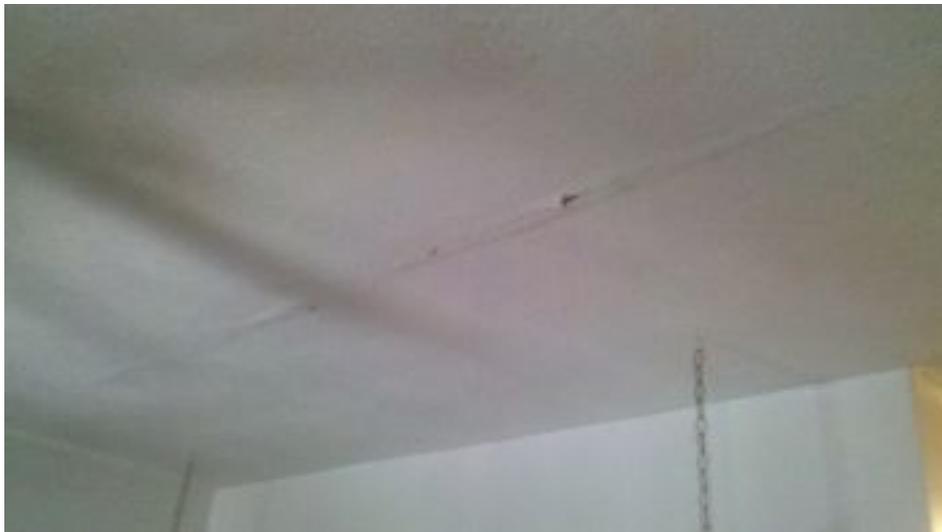
- 12" ceiling tiles may contain asbestos.
- 9" vinyl floor tiles may contain asbestos.
- Staining noted on underside of roof. Leak is active. staining noted on master bedroom ceiling

active ceiling stain in master bedroom

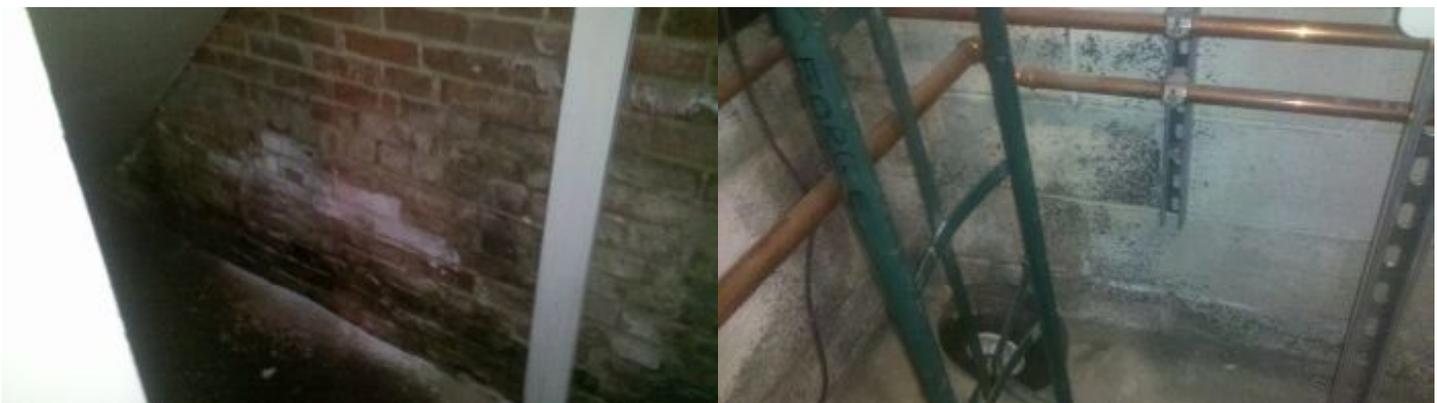
- Persistent seepage noted. It appears that the current water proofing system is insufficient. Additional water proofing systems are required.
- A substance which appears to be mold is growing on the foundation walls. Additional testing by a firm who specializes in mold is needed in order to determine the necessary measures needed to remediate this issue.

efflorescence and water staining on the foundation

mold and efflorescence on foundation

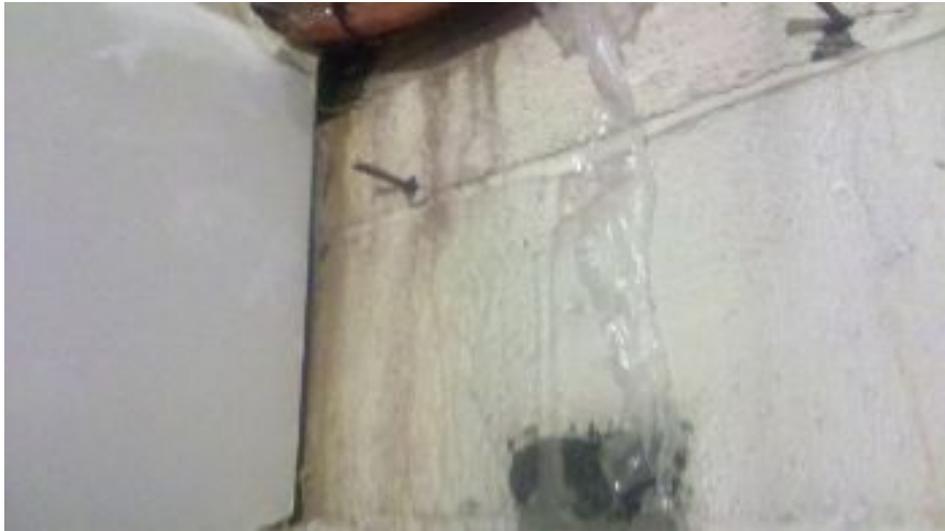
water stains on foundation walls

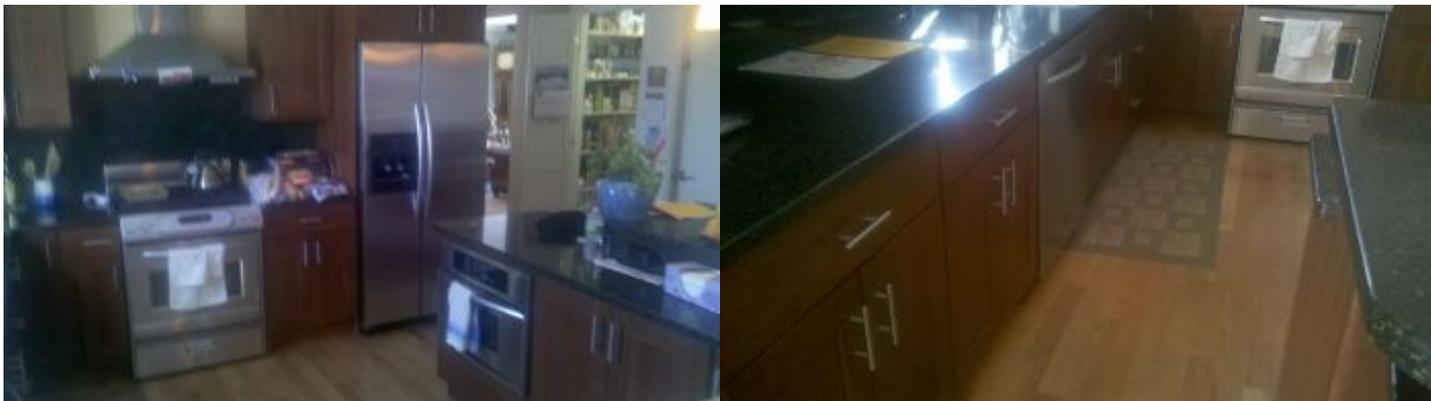
- Burner does not light with electric ignition: front right
- The oven is in need of cleaning.

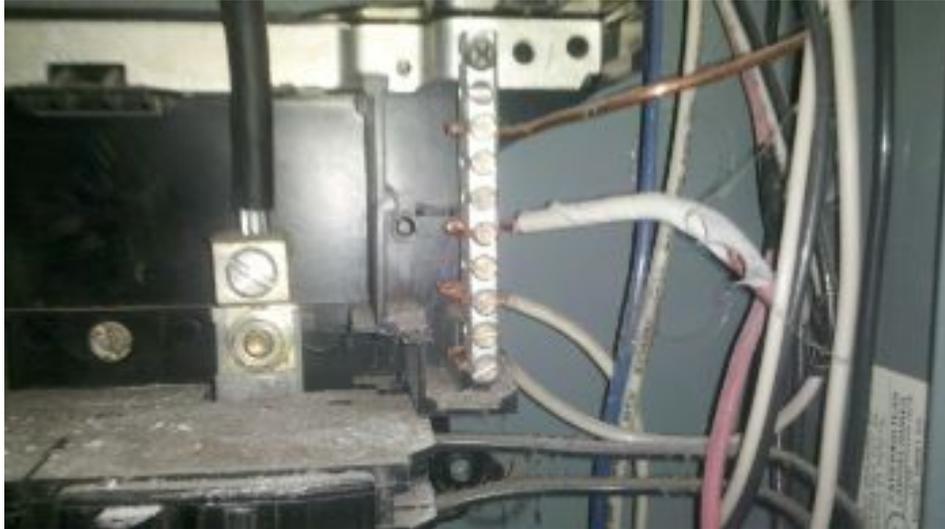
- **Federal Pacific panel(s) were noted. Consult a licensed electrician for upgrade.**
- **Inappropriate workmanship: Mixed grounds and neutrals noted in sub panel. Consult licensed electrician for repair.**

mixed grounds and neutrals in panel

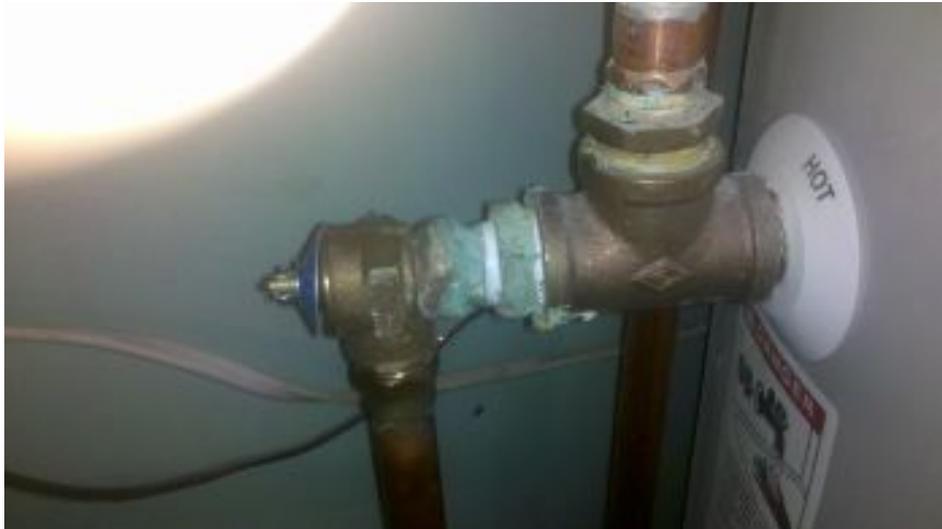
- Caulk and grout work is needed in bathroom(s).
- The toilet is loose and should be reset.
- The water heater temp/pressure valve does not have an extension pipe which is long enough, and there is corrosion on the connection..
- Pop up drain control does not function in the: main bath / tub

corrosion and short extension on water heater t/p relief valve

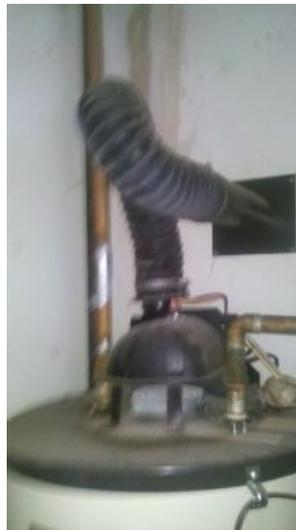
- The water heater has outlived its life expectancy. Immediate replacement is advised.
- The water heater flue is improper and should be changed.

improper flue on water heater

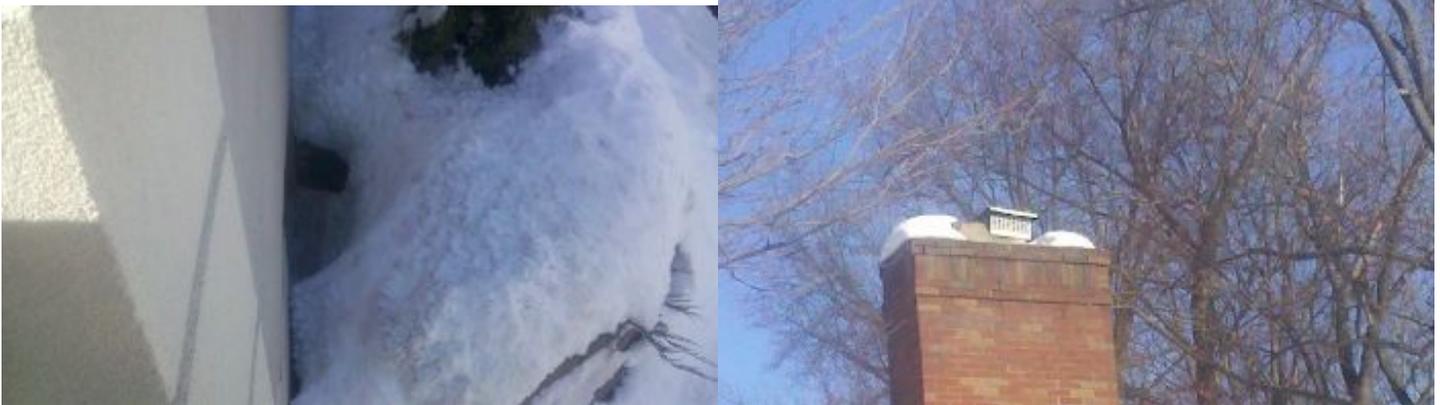
uncovered window wells

cap needed on heat chimney flue

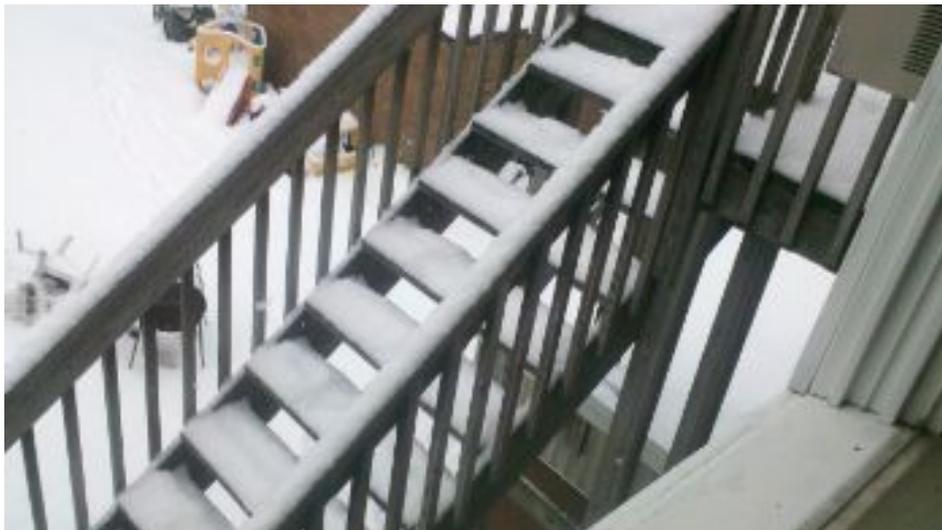
- The roof has outlived its life expectancy. The shingles are deteriorated, broken, missing, and loose. Immediate replacement of the roof is advised.
- The stoop is in poor condition. Repairs are needed. The acquisition of multiple estimates is advised.
- Note: Swimming pools and pool equipment are not part of this inspection.
- Note: Underground sprinkler systems are not part of this inspection.
- The exterior components are covered with 6 to 12 inches of snow cover. The roof, walks and grounds could not be fully inspected. Additional inspection is required in order to fully evaluate these components.
- open kicks were noted on the deck stairs

open kicks on deck stairs
